Focus on IFA's work

Edition 1/2015

Safety risks of maintenance work on hydraulic machinery

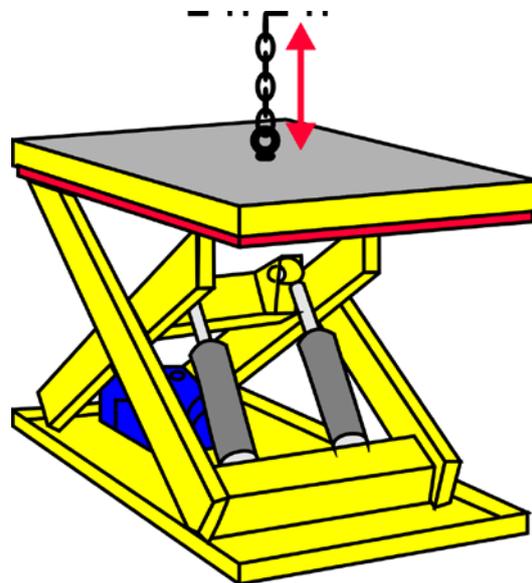
Schematic diagram of a hydraulic lifting table pulled with the chain hoist at its highest point

Raising the hydraulic lifting table with a chain hoist created a partial vacuum in the hydraulic lifting cylinder. Because the hydraulic oil reservoir was located under the lifting table, not enough hydraulic oil could flow through the valve gaps into the lifting cylinder even after a long period during which the machinery was immobile. Yet the hydraulic safety equipment (valves and pipe breakage protection valves) is only operational if the entire hydraulic system including the lifting cylinder and the pipes are filled with hydraulic oil so that the oil column can bear the weight of the load. If this cannot be adequately confirmed,

hydraulic lifting tables and similar equipment must be put and held in a secure end position both from above and from below by a chain hoist or similar device for the duration of any maintenance work.

Because several similar accidents have become known, hydraulic machine manufacturers should provide suitable information in their user guides and manuals about the known risks during maintenance work according to the requirements of DIN EN ISO 12100 section 6.4.1.3. Equipment operators and owners as well as maintenance firms should make certain that their personnel are sufficiently competent and that user information and manuals are available at or on the machine.
